# REPORT ON THE RESTORATION OF WETLANDS, SPRINGS AND STREAMS IN A MOUNTAIN LANDSCAPE

IVANA BUFKOVÁ<sup>1,\*</sup>

<sup>1</sup> Šumava National Park Administration, Sušická 399, 341 92 Kašperské Hory, Czech Republic

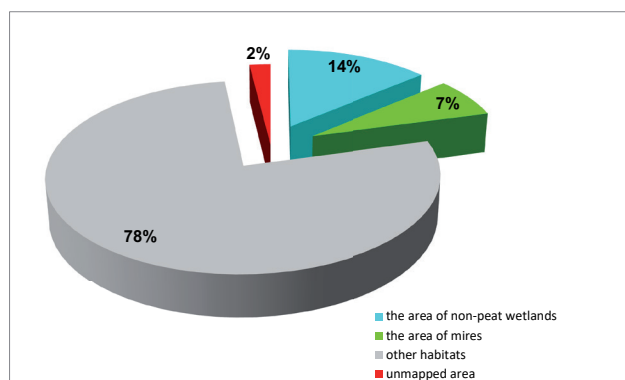
**Fig. 1** Percentages of the area of the Šumava National Park that are made up of wetlands (unpublished data from habitat mapping NCA, 2023).

The Šumava National Park (680 km<sup>2</sup>) and adjacent Protected Landscape Area (996 km<sup>2</sup>) are important wetland and mire regions in Central Europe and together include most of the SCI<sup>1</sup> Šumava involved within the Natura 2000 network. In this area there are wetlands at high altitudes (around 1300 m a.s.l.) and in the foothills (around 800 m a.s.l.). According to results of habitat mapping by the Nature Conservation Agency of the Czech Republic (NCA) in 2023 (NCA 2023), wetlands make up more than a fifth of the Šumava National Park (Fig. 1).

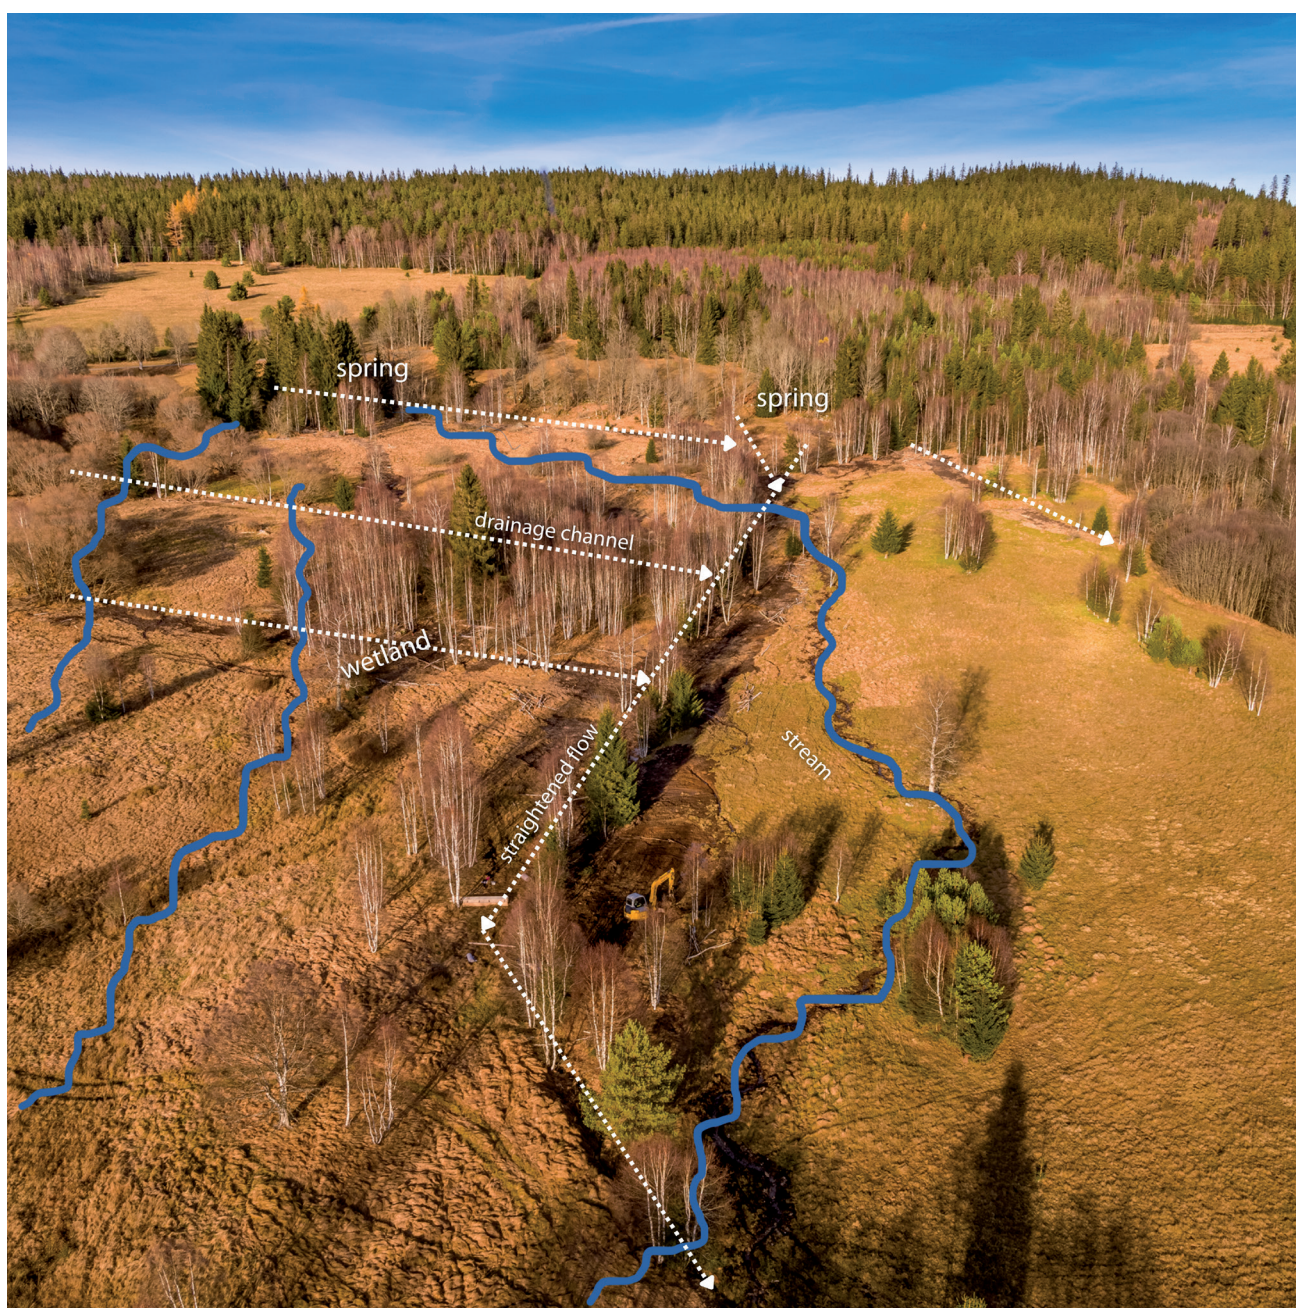
**Fig. 3** An annotated photograph of an example of the hydrological restoration of a micro-catchment on the slopes of the Křemelná basin (in blue), which previously included drained springs, wetlands and straight water courses, location Pod Skelnou, 2022 (photographer R. Plíhal).

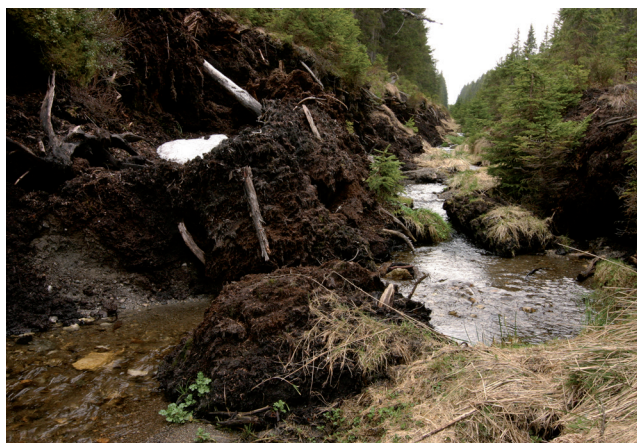
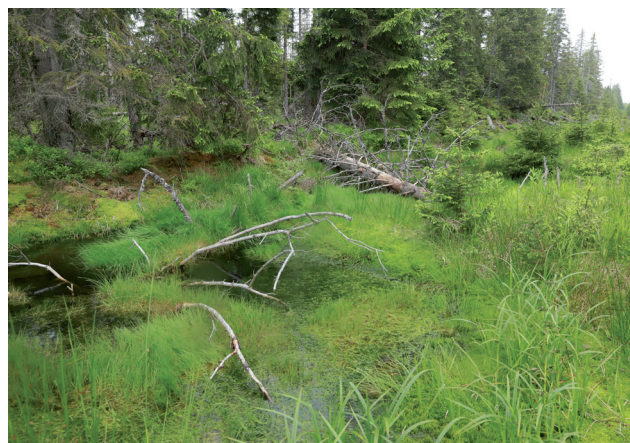
**Fig. 5** Deep erosion gully along the former “Iron Curtain” at Černošský močál above the Vltava River before restoration in October 2014 (a) and after channel damming and backfilling in July 2024 (b). The streams are now stabilised by mire and wetland vegetation (photographer I. Bufková).

The installation of only dams, however, is not sufficient, because they are likely to be damaged by water erosion and the limited lifespan of wooden dams. Each wooden barrier must be surrounded by compacted earth or peat backfilling of usually 1–2 m on both upstream and downstream sides. This backfilling stabilizes the dam, reduce its susceptibility to erosion and extends its life. And finally, backfilled dams should be combined with subsequent infilling of the spaces between them, which results in rapid overgrowth with wetland vegetation and final elimination of the channel (Fig. 5).

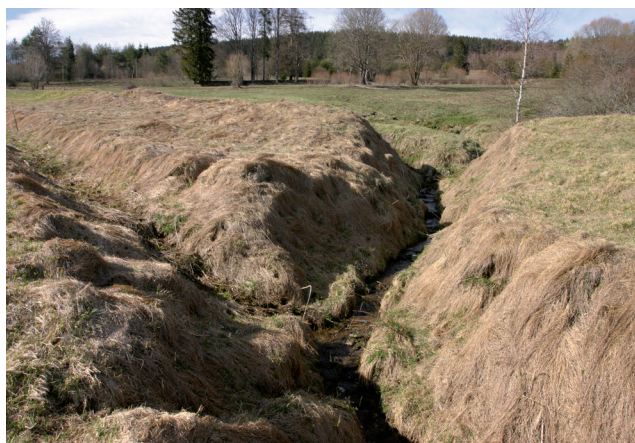
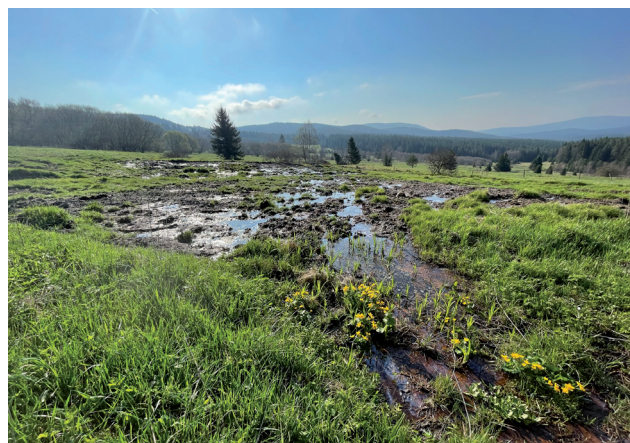
**Fig. 6** Spring in a large meadow at Pod Skelnou one year before restoration (a) and two years later (b), April 2019 (photographer I. Bufková) and May 2022 (photographer L. Linhart).

All the drainage ditches were filled with soil after damming (Fig. 6), as material other than soil is not recommended. Before starting the restoration, the original extent of the spring was determined. In the case of piped springs, all pipes including any lateral drainage system were removed. When restoring the outflow from helo-crene springs, several (at least 2–3) small outlets were created, which take the form of an opposite delta usually only a few meters below the spring.

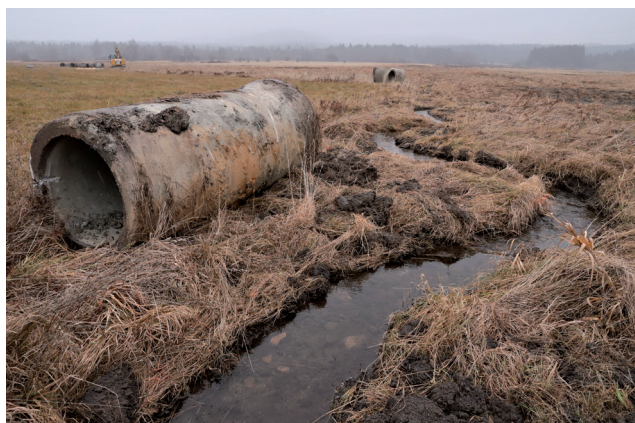
**Fig. 7** Photograph showing the result of restoring a small stream that was previously drained using the pipes at, Dobrovodské louky, November 2021 (photographer I. Bufková).

The creation of a new stream bed in the original run-off route is the most common method used for restoring watercourses in the Šumava region (Fig. 7). The bed was re-shaped with the help of an excavator in sections where the water flowed in the past, but no historical stream bed has been preserved. When creating a “new” bed for very small streams, the geomorphological pattern of preserved natural streams occurring in comparable conditions in the vicinity was used. Shaping has always been directed towards restoring a broad but shallow bed. The depth of the newly formed small streams (with an average flow of a few litres per second) did not exceed 25 cm. In streams with channel widths of up to 0.8 m, typical features of bed morphology (riffles, pools, point bars) were only rarely replaced; their formation was assumed to occur during the subsequent development of the stream. In contrast, for large streams, measures to restore bed morphology (according to Just et al. 2021) are implemented or at least initiated.

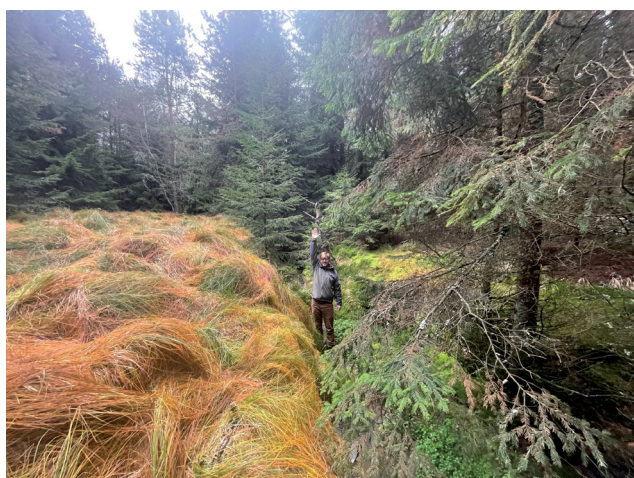
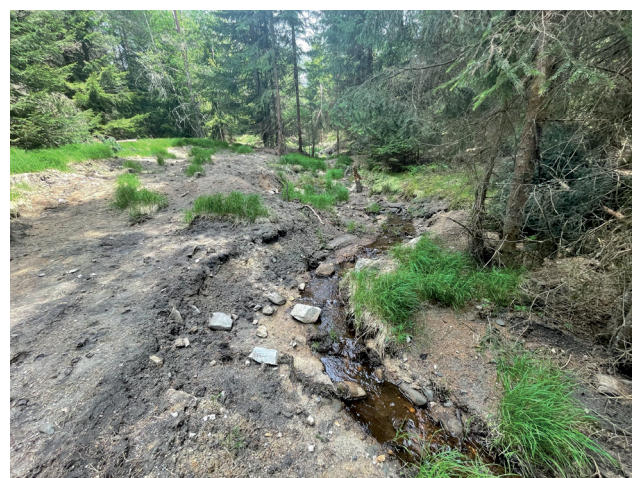
**Fig. 8** Deeply incised and straight stream at Rovina just before restoration in October 2022 (a) and one year after its return to a natural state (June 2023) (b) (photographer L. Linhart).
